### **ROUTE 63 CORRIDOR STUDY**

# REVISED DRAFT EXISTING AND FUTURE CORRIDOR NEEDS

Genesee, Wyoming and Livingston Counties, New York

March, 2003

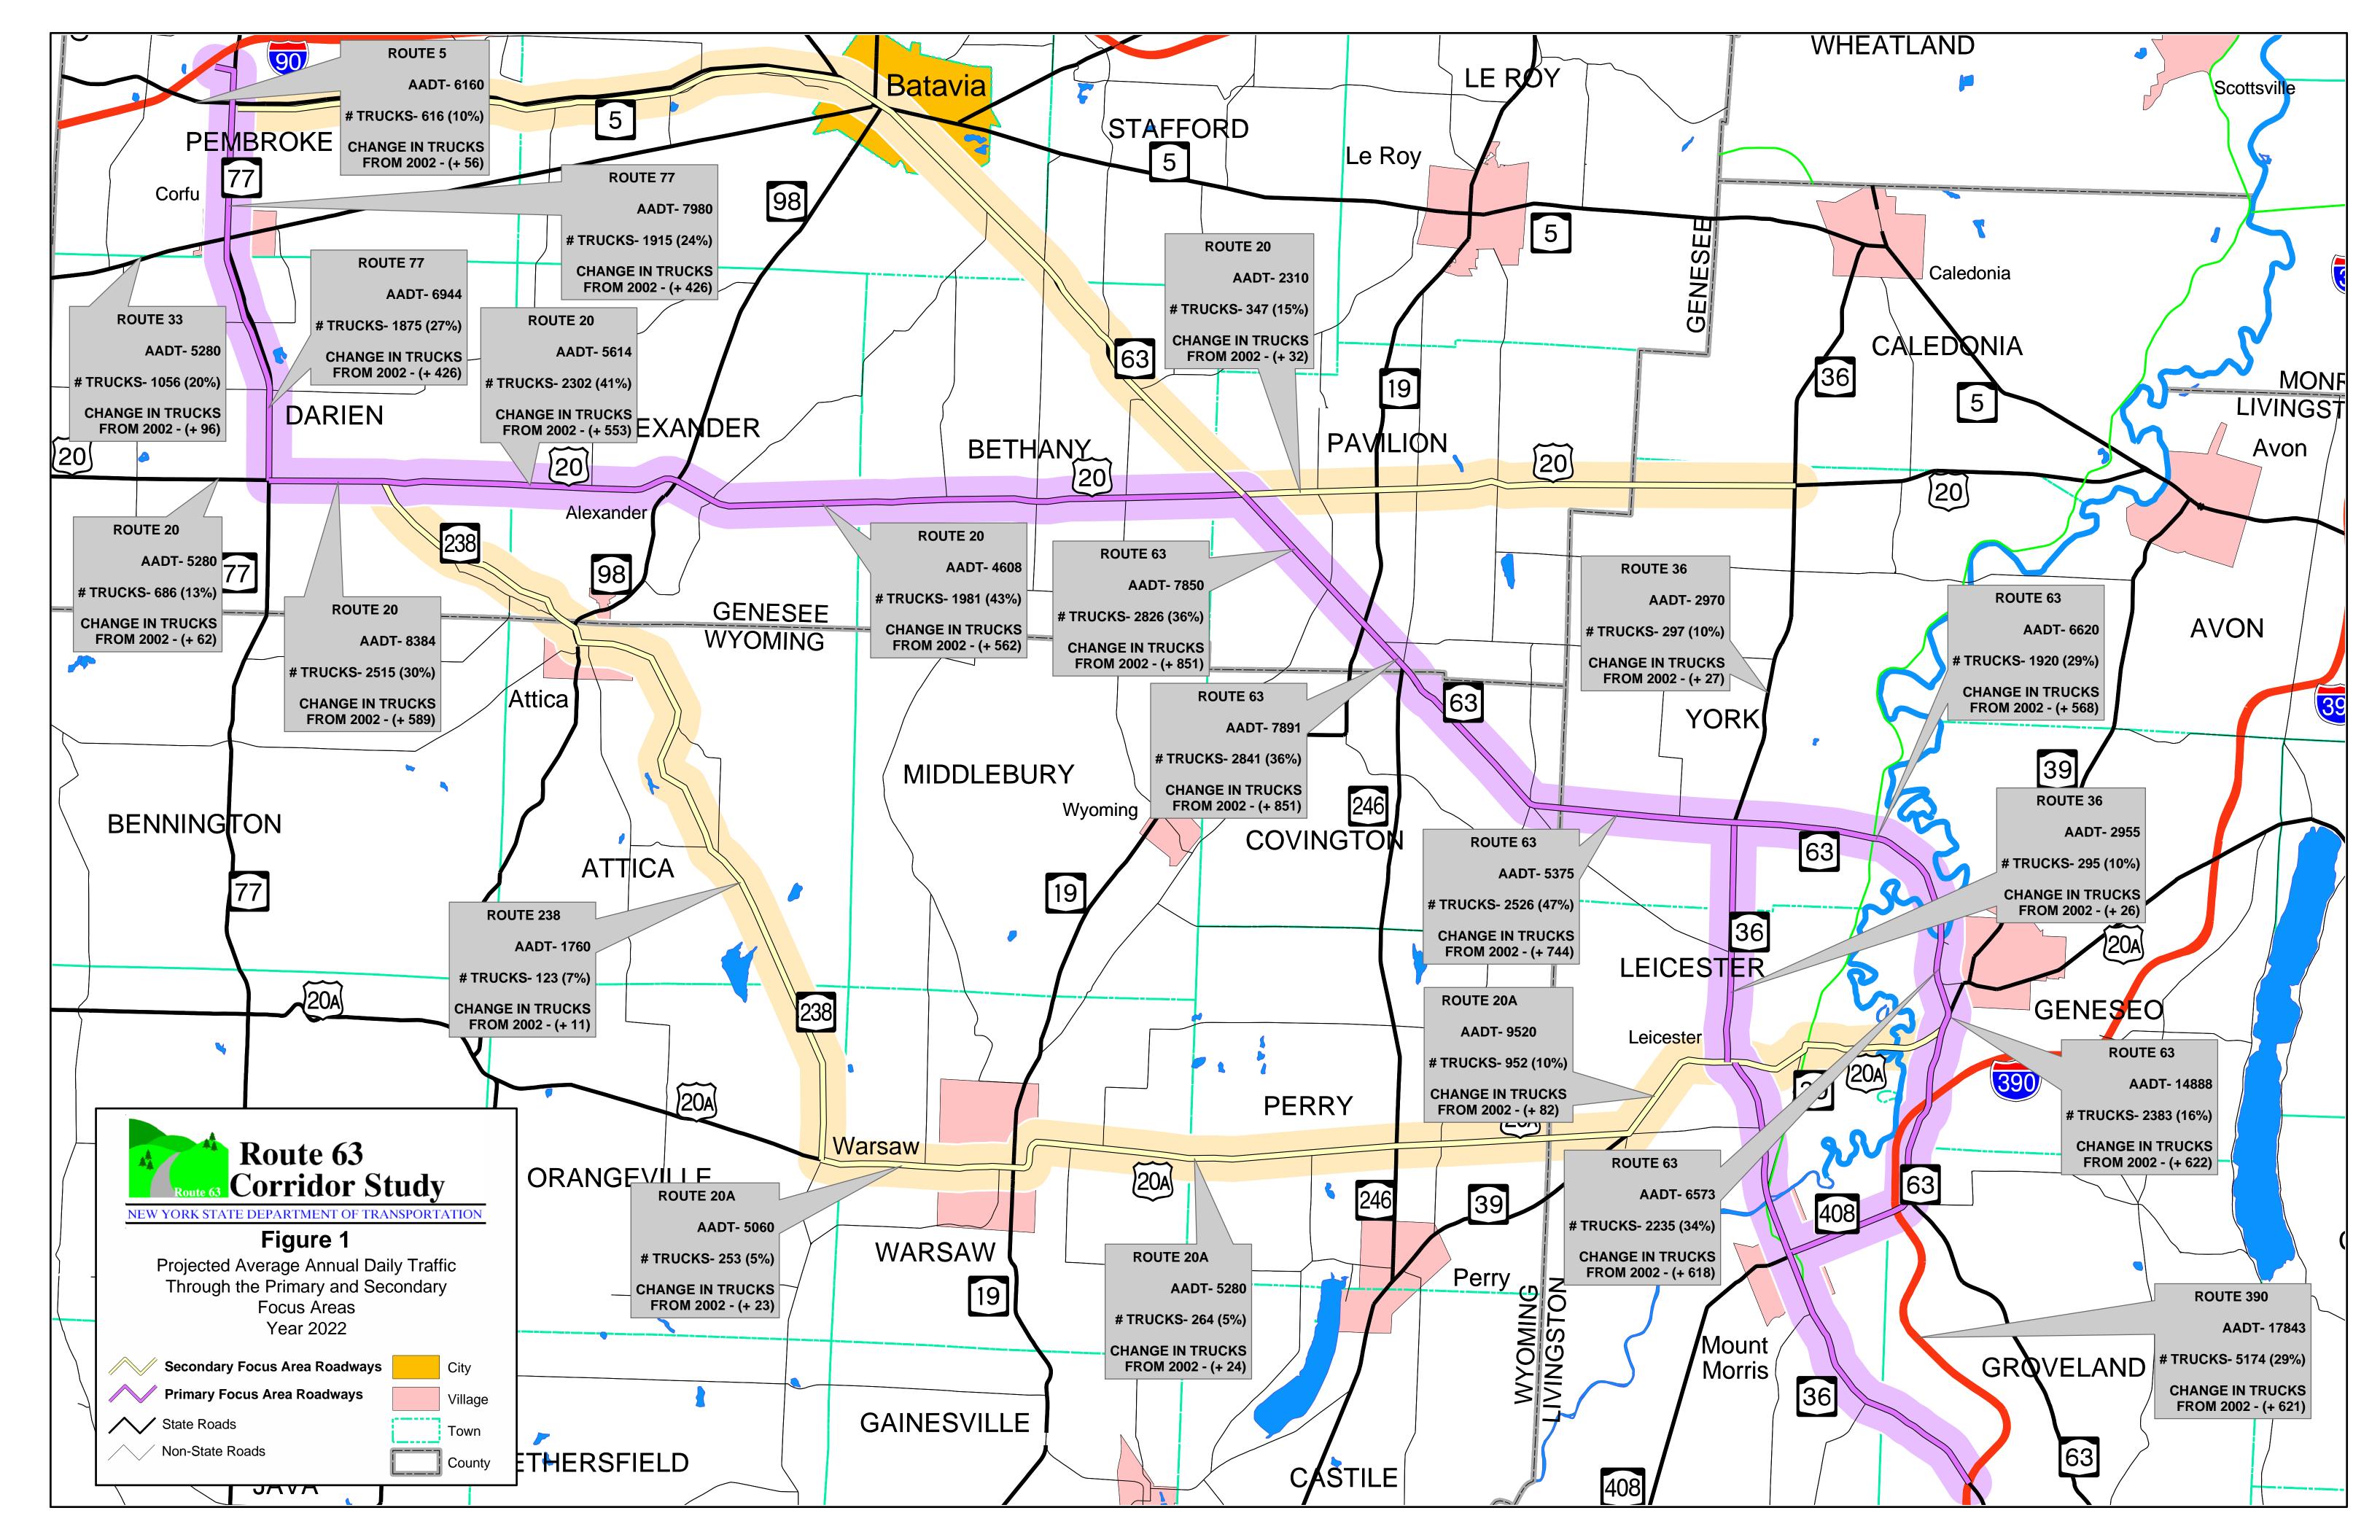
To estimate future truck and traffic volumes, the background and pass-through growth rates were applied to existing volumes and factored out over a twenty-year period. For primary corridor roadways, both the background growth rate of 0.5% per year and the Northeast US/Canada trade area growth rate of 3.5% per year were applied to the respective traffic components, as these roadways contain a mix of Northeast US/Canada trade area trucks and other traffic. For the secondary roadways, it was assumed that all traffic would be classified as corridor-wide and western New York, as trucks are not regularly using these roadways as pass-through routes. As such, only the background growth rate of 0.5% per year was applied to the existing volumes along the secondary roadways. The projected 2022 AADT volumes are presented on *Figure 1*. As shown, truck volumes are expected to increase between 400 – 800 units per day along the primary corridor, depending on location.

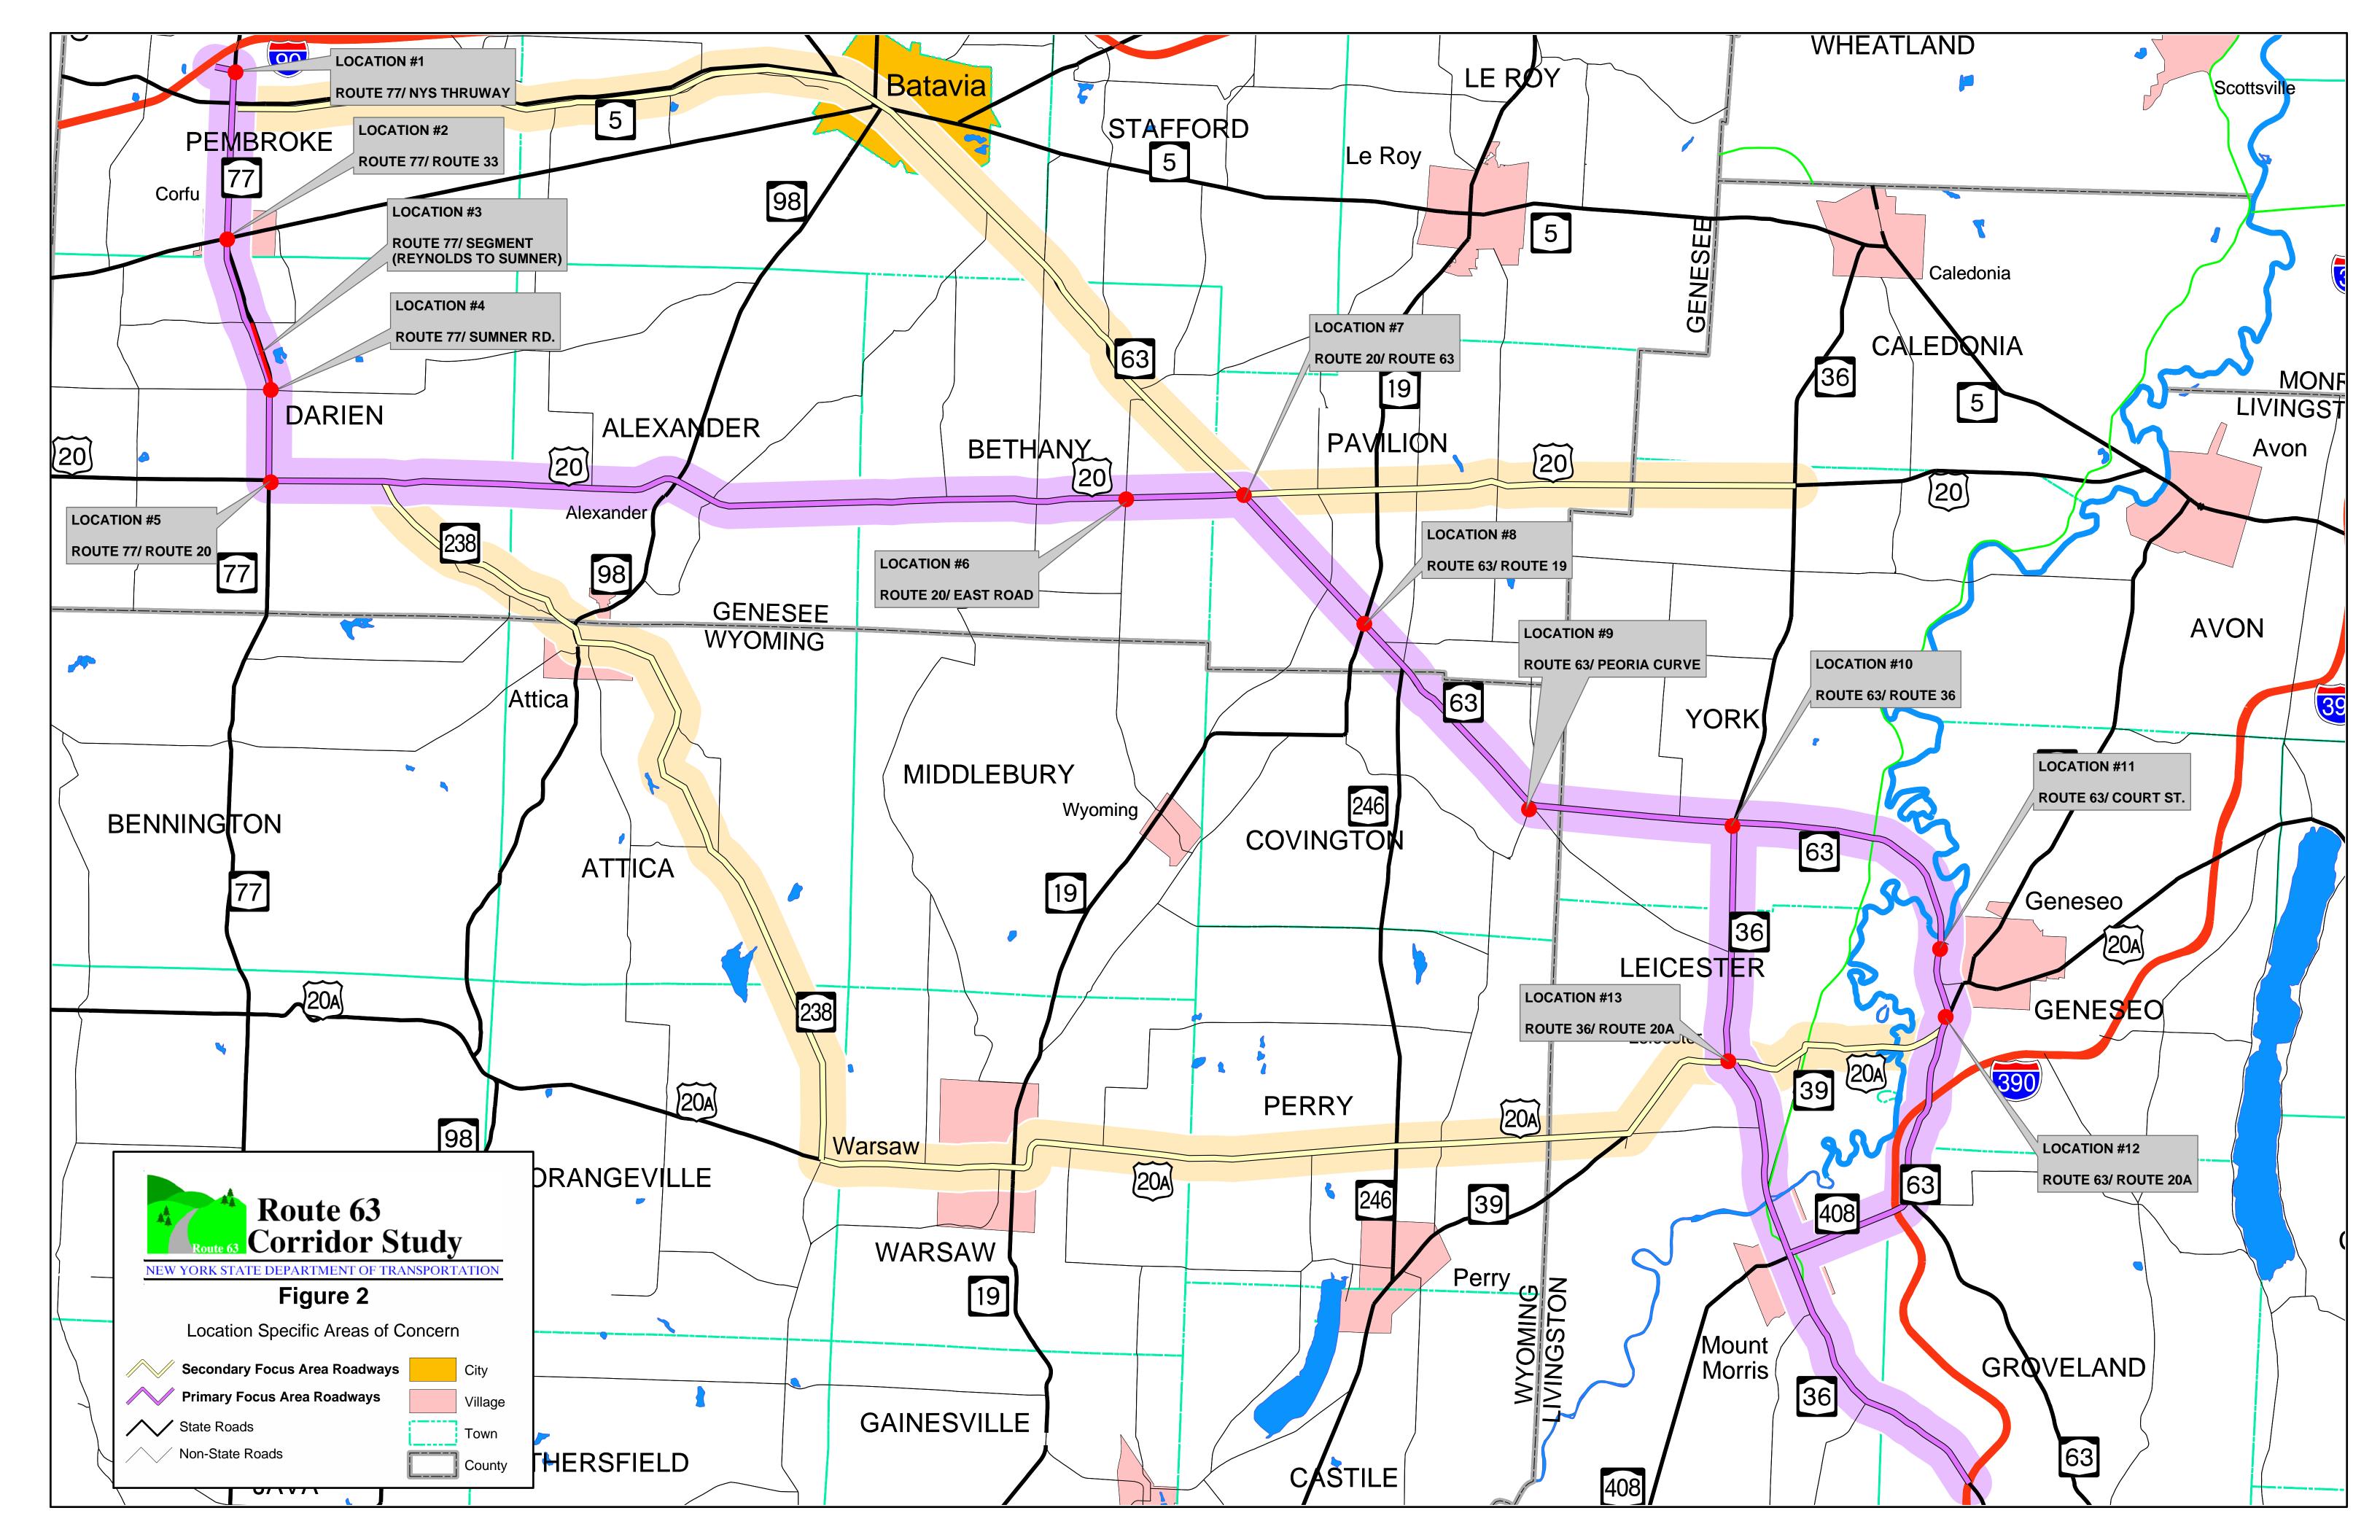
The accident analysis conducted found that twenty-three (23) accidents occurred on the approaches to these intersections, the most prevalent types being rear-end and right-angle accidents (7 each). The majority of the right-angle accidents occurred on the Route 36 northbound approach to Route 20A (at the east intersection) and involve northbound and eastbound vehicles. There were no clear patterns identified for other accident types. Heavy trucks were involved in only 9% (2 of 23) of the total accidents at this location.

This intersection is located in the Village of Leicester in a section where traffic has been slowed to Village conditions. At the first round of public input meetings, safety conditions at these intersections were raised as a concern by local residents.
